Description of the property

This property is not included in the sale of Gevåg 1:36!

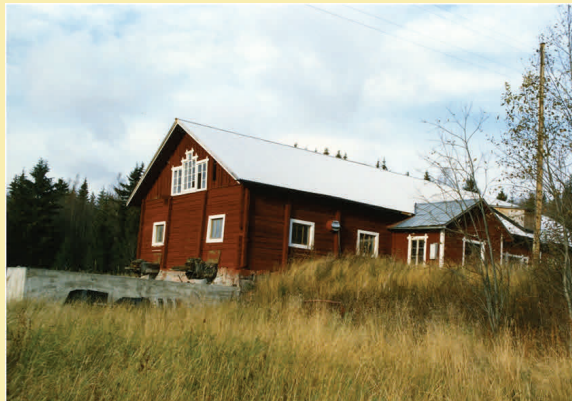
Cow stable

Timbered building from 1850. Renovated 1980.
Has been used as a cowstable with place for about 20 cows.
Now used as a storage.

The building has a manure plate of concret.
Roof of sheet metal

The building is not approved for animal production, due to European Conditions.

The timber building is good, but has some foundation problems on the north side.
The floors on the north side needs some renovation.

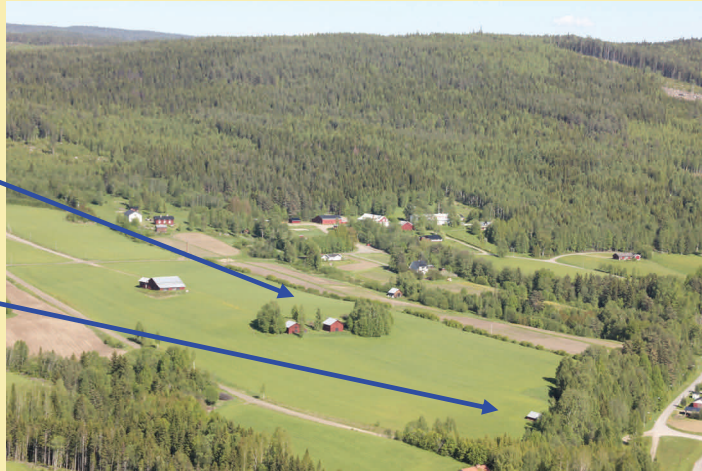
Smaller barn

Two hay barns, one is build of timber and one of planks.
Foundation of natural stone

The larger ones are in good shape.
The smaller one needs a new foundation.

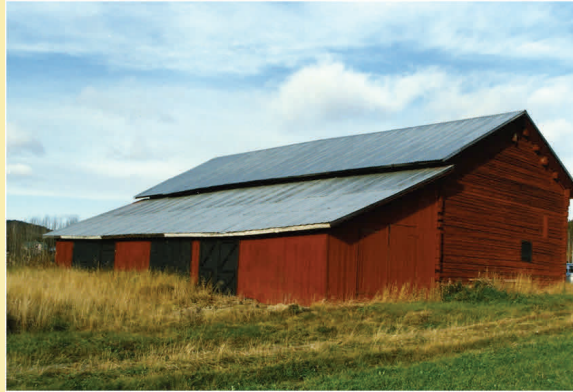
Barn

Timbered building from 1850 with fondation of natural stone. It has been used as a hay barn and storehouse.

The building is in good shape

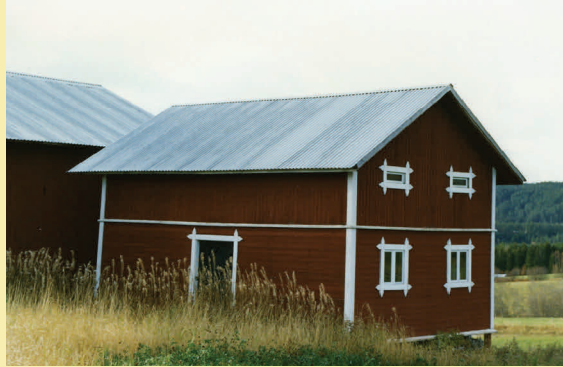
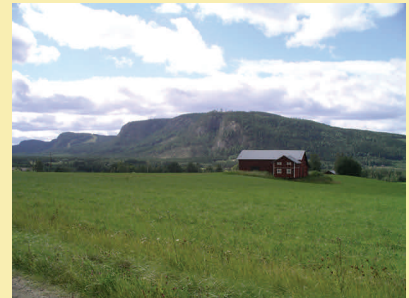
Grain barn

Barn standing on concrete plints, with fasade of wood.
Etage 2 has been used for grain storage.

The building is in good shape
